### Volume 16, Issue 8

**Medical Product Safety Network (MedSun) Final Survey Report**  
**Topic: Syringe Pump Survey**  
**July 2015**

## HIGHLIGHTED REPORTS

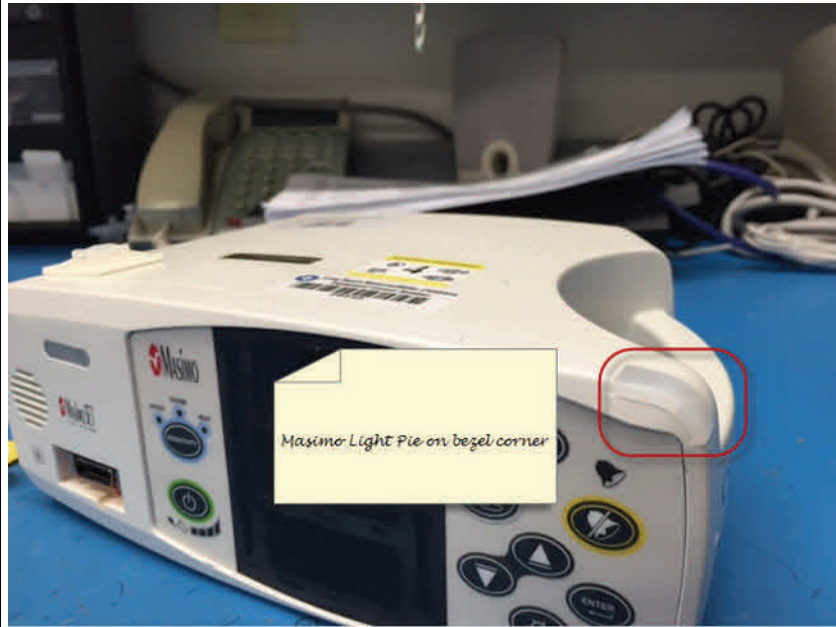
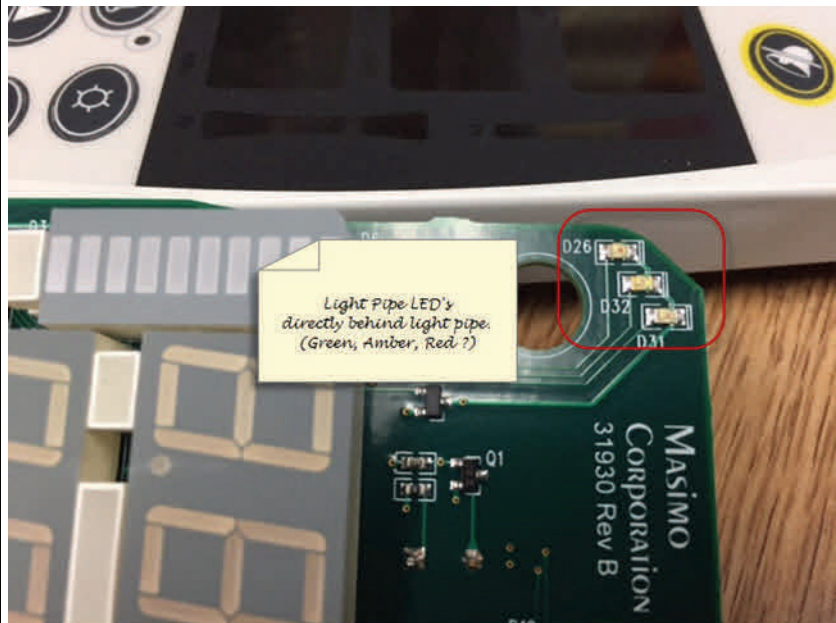
| <p><b>Oximeter</b></p> <p><u>Brand:</u> Rad-87</p> <p><u>Model#:</u> Rad-87</p> | <p>Masimo Corporation</p> | <p>During testing and equipment history review Biomedical Engineering noted excessive failures with our portable pulse oximeter monitor's visual alarms. During alarms, the monitor's Red alarm LED would not flash. The clinical team would respond to the monitor's audible alarm and overhead door light when the monitor alarmed. The clinicians would not report that the RED LED was not flashing. Biomedical review of several monitors noted that the alarm LED was inoperative. Biomedical sequestered all of the affected pulse oximeters and has arranged for factory evaluation and repair. There were no reported patient adverse events.</p> <p>=====</p> <p>Manufacturer response for Monitor, Pulse Oximeter, Rad-87 (per site reporter)</p> <p>=====</p> <p>Awaiting follow up by manufacturer.</p> <p>On-site testing by Biomedical confirmed that red LED alarm lamp did not illuminate during alarm event. All other Display activities and audible alerts did function correctly. Biomedical collected 10 additional pulse oximeters with the same failure. All 11 will be sent in to the manufacturer for evaluation and report. These devices are approximately 6 years old.</p> <p>The facility is afraid these might be getting hit (during normal use and transport) on the corner causing these failures. They have been having Light pipe breakages since day one on these monitors.</p> <p>Please see pictures below:</p> |

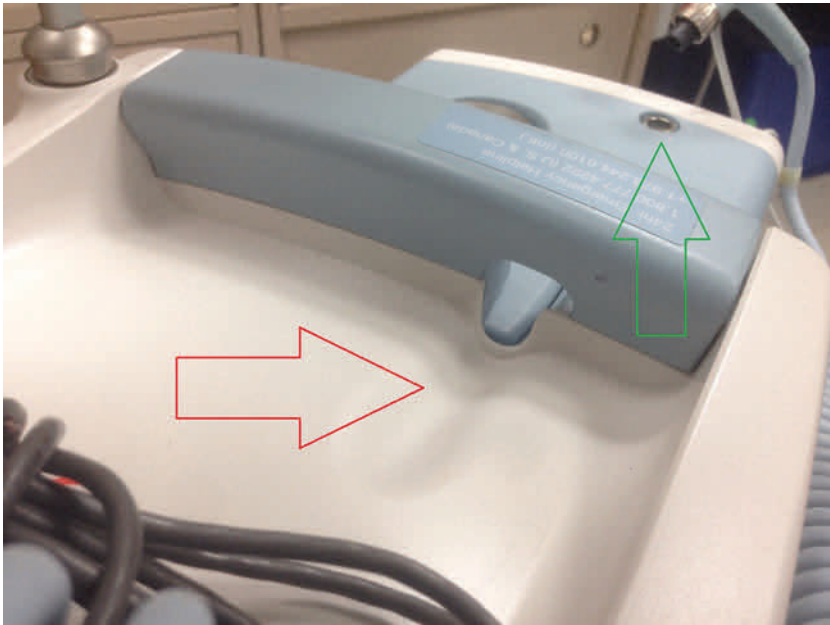
| <p><b>System, Balloon, Intra-aortic</b></p> <p><u>Brand:</u> Cardi-osave Hybrid</p> | <p>Maquet Medical Systems USA</p> | <p>The Maquet Cardiosave Hybrid Balloon Pump has a poorly designed top panel. The panel is designed such that any liquid that finds its way into this area will be funneled directly into the 14 pin monitor connection site. When saline was applied to this connection site the machine shut down. The top panel is labeled with signage discouraging the placement of IV bags in this area.</p> <p>However in practical use fluid will find its way onto this panel. Even a small amount of liquid will flow directly to the monitor connection site because of the funnel design. This top panel should be redesigned to prevent the flow of liquid into the monitor connection site or a liner should be applied to the top panel to collect liquids and prevent their flow into the monitor connection site.</p> <p>Please see picture below:</p> |
